CALVER MILL

Lynn Willies

Abstract: The site was a smelting mill from at least 1616 to 1773, and in the mid- or late 19th century was rebuilt for cornmilling, ceasing work probably before 1914. Water from two mine soughs fed the cornmill dam. Rebuilding for domestic use in mid-1987 has destroyed many features but gave opportunity for a rapid survey.

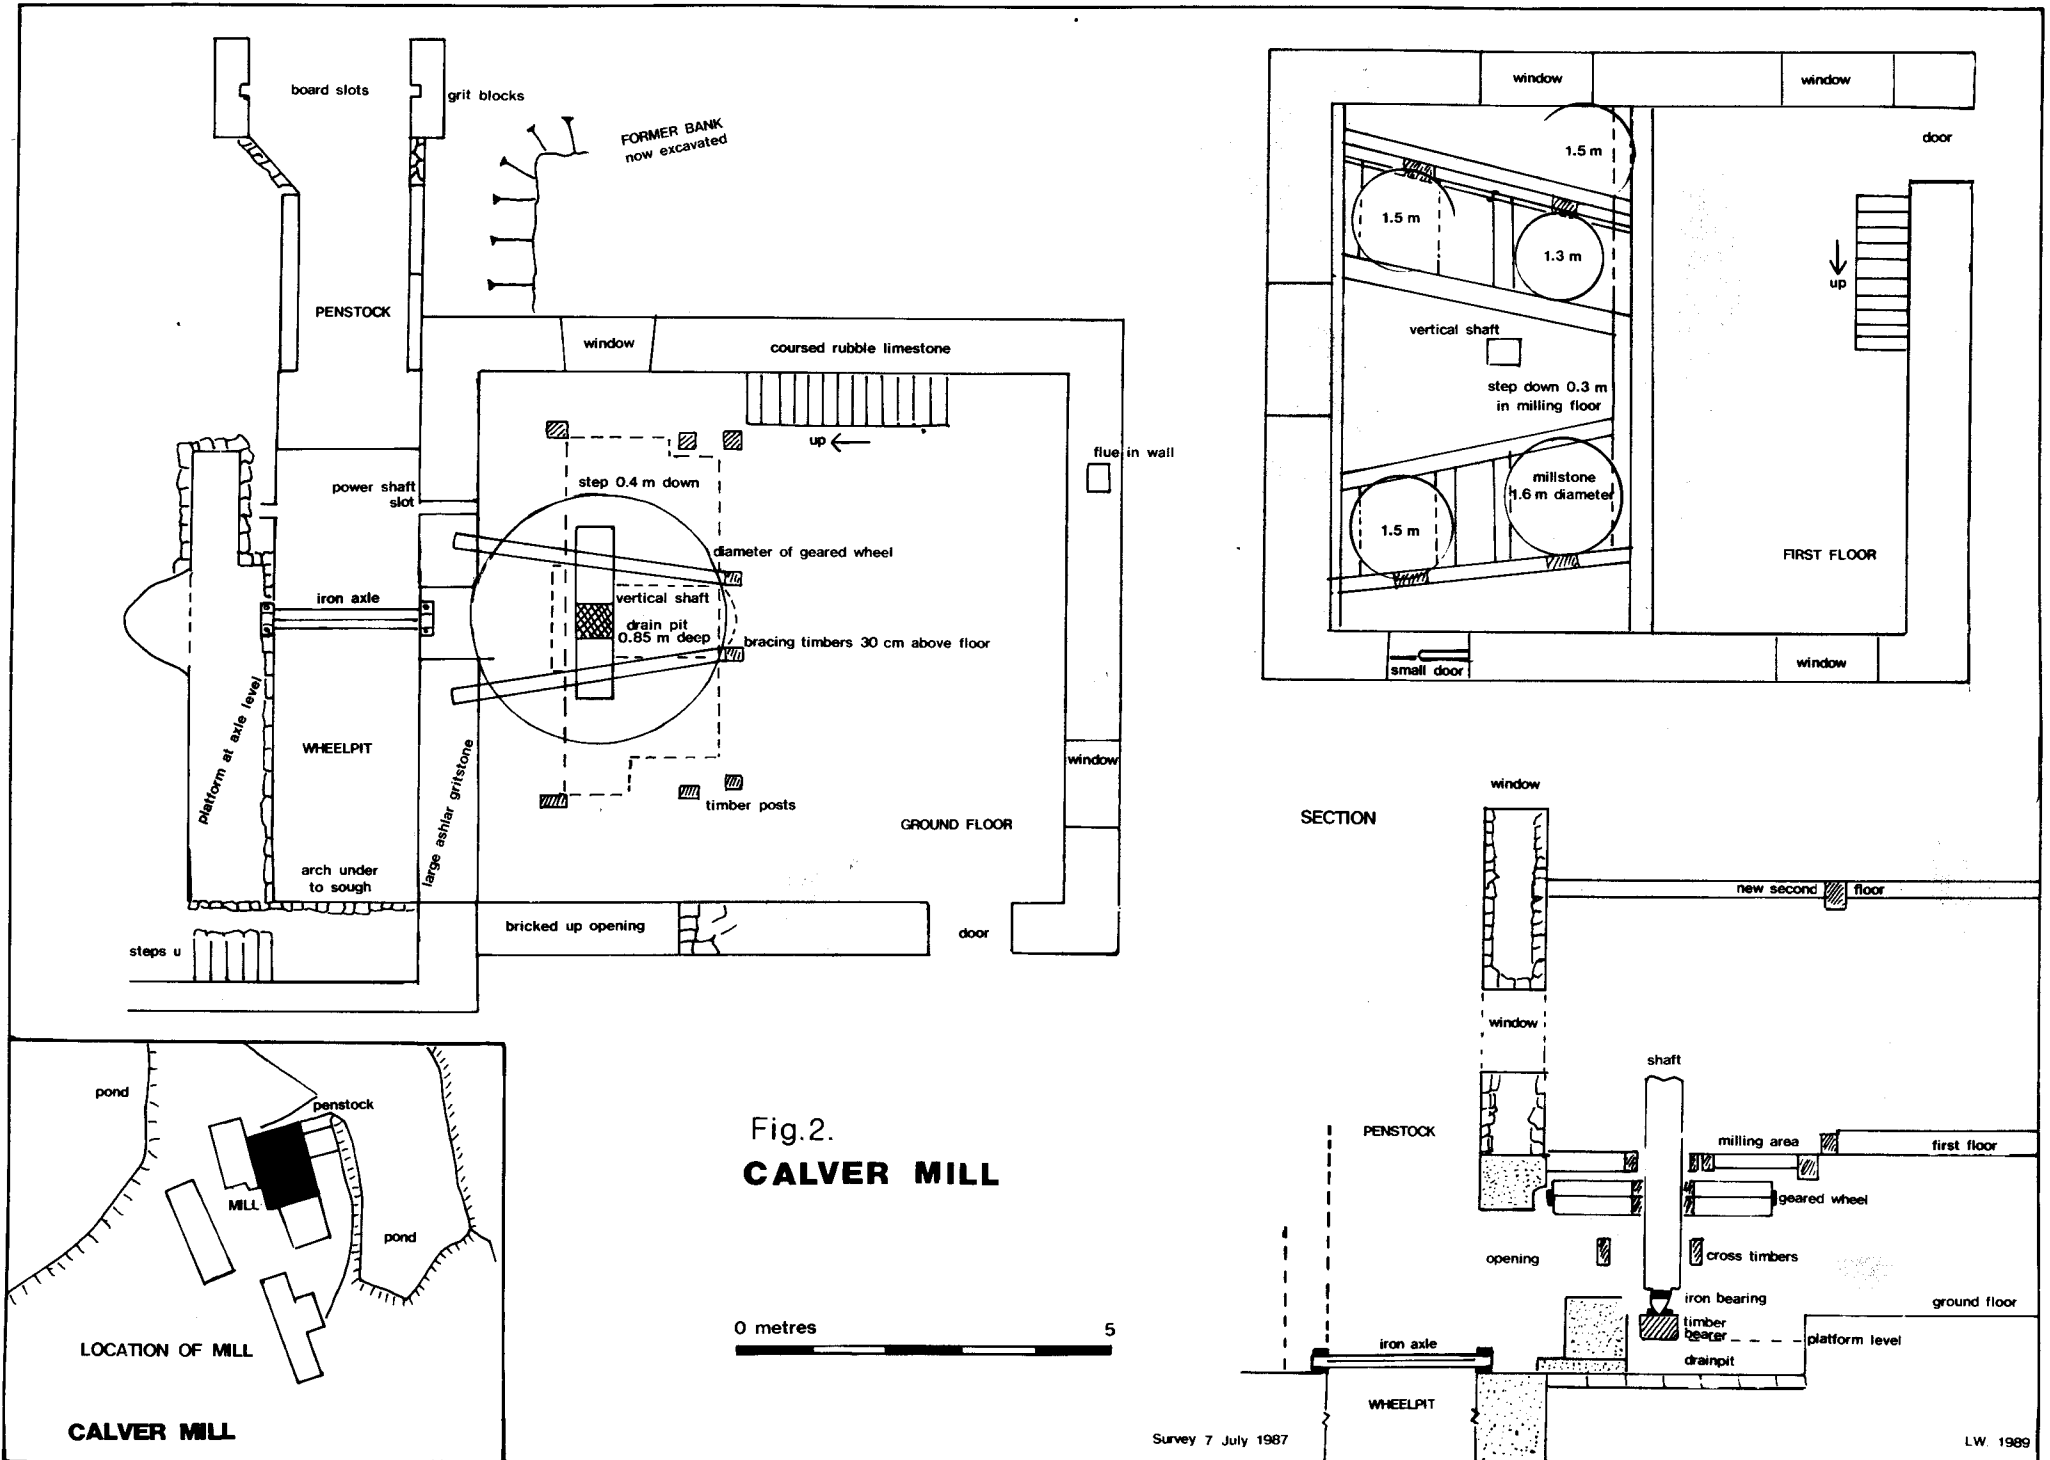
Calver Mill - the mill building is on the left, with the wheelpit protected by the chestnut paling. The centre building is later, linking the mill to the possibly older building, right.
